# ColLab Garden

## TITLE: Co-Creating The Future Of The GFL Greenhouse

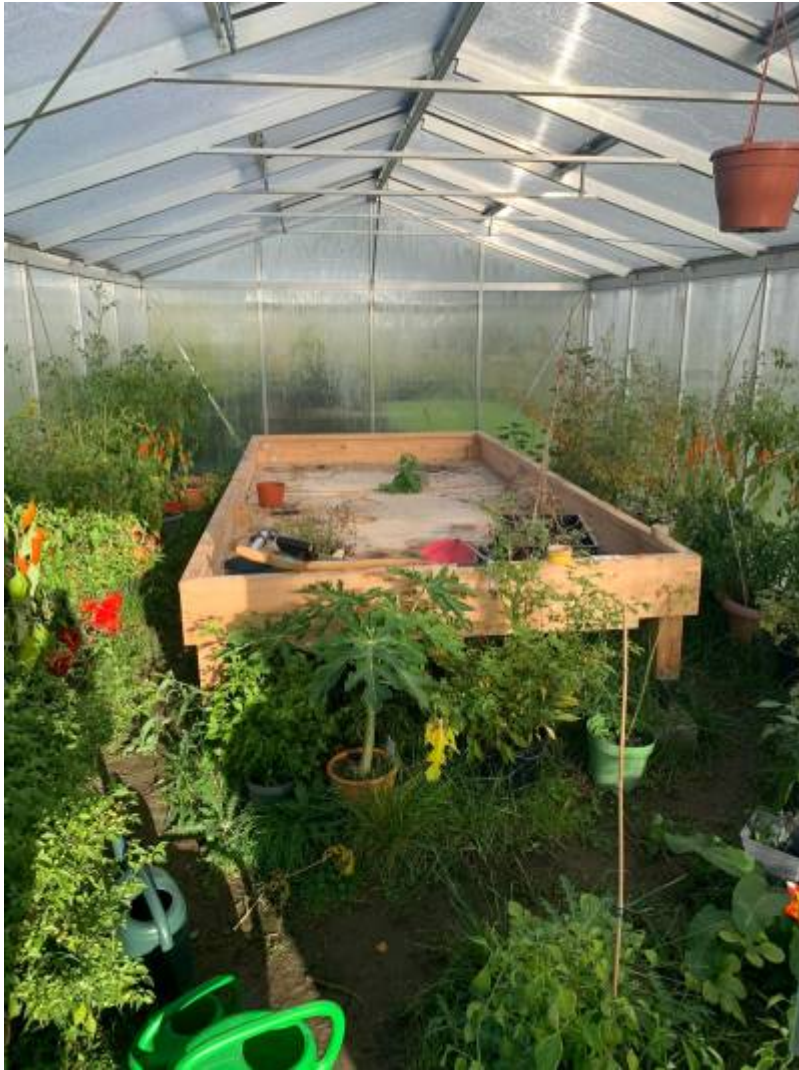
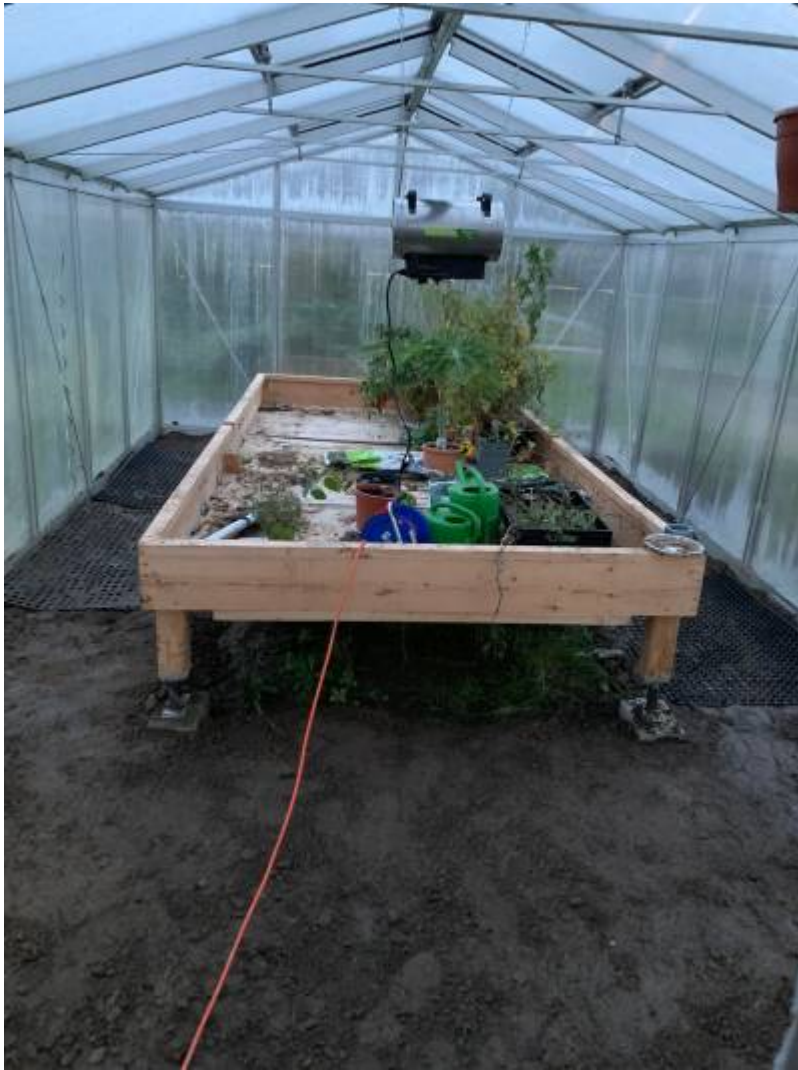
Fig - 2 Progress of Greenhouse before and after cleaning (Front view)

Figures **2** and **3** show the progress of cleaning both from the front and the side view

Since there were already various plants in the greenhouse, it was essential to clean the space from them. That step became necessary due to the number of weeds and grasses. Plants such as peppers were planted in pots, and it was necessary to move them to another place because they interfered with the cleaning stage and laying the floor with mats. At this step, we used shovels, trolleys for transporting plants and garbage, rakes, gloves, and hoes.

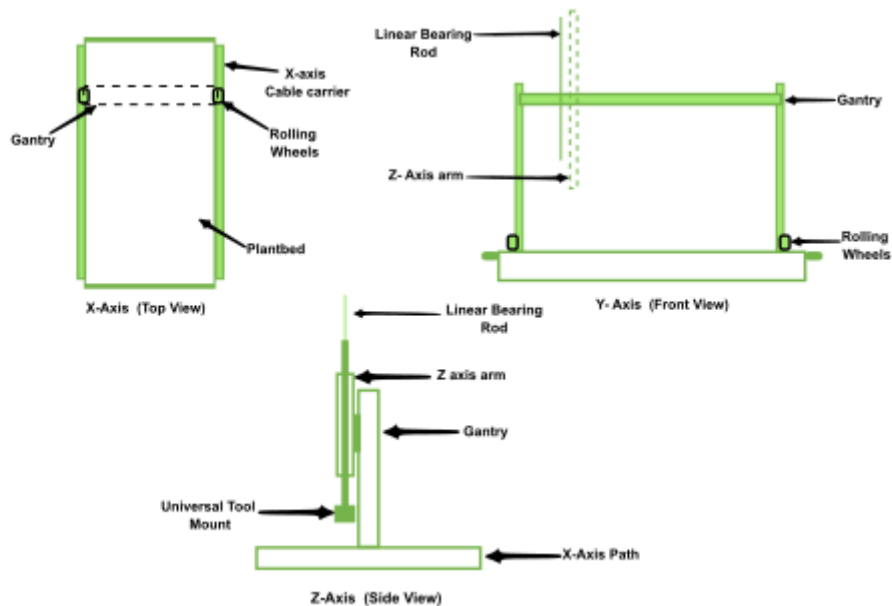
Fig - 4.1 Line Diagram structure of Farmbot

FarmBot Genesis XL version 1.6. It was chosen because of its multifunctional capabilities, ranging from planting a seed to nursing it to maturity. Additionally, it excelled in weeding and soil sensitivity measurement. Besides being autonomous in numerous functions, it was also built upon open-source data that could be modified based on preferences and needs. Its components all contributed to an advanced approach to farming, especially on an individual level. The progress in building the Farmbot was documented in the pictures shown below in Figure 4. Most importantly, the FarmBot could be assembled and used not just by technology experts but also by individuals with little to no experience in the field. Its main parts were the gantry with a Z-axis hand and the tracks for movement with cable carriers. It also had several tools for seeding, weeding, and watering placed in a toolbar at the edge of the plant bed. Finally, there was a main electrical box attached to it that oversaw all operations. A simple diagram showing the Farmbot view from all 3 planes could be seen in Figure 4.1.

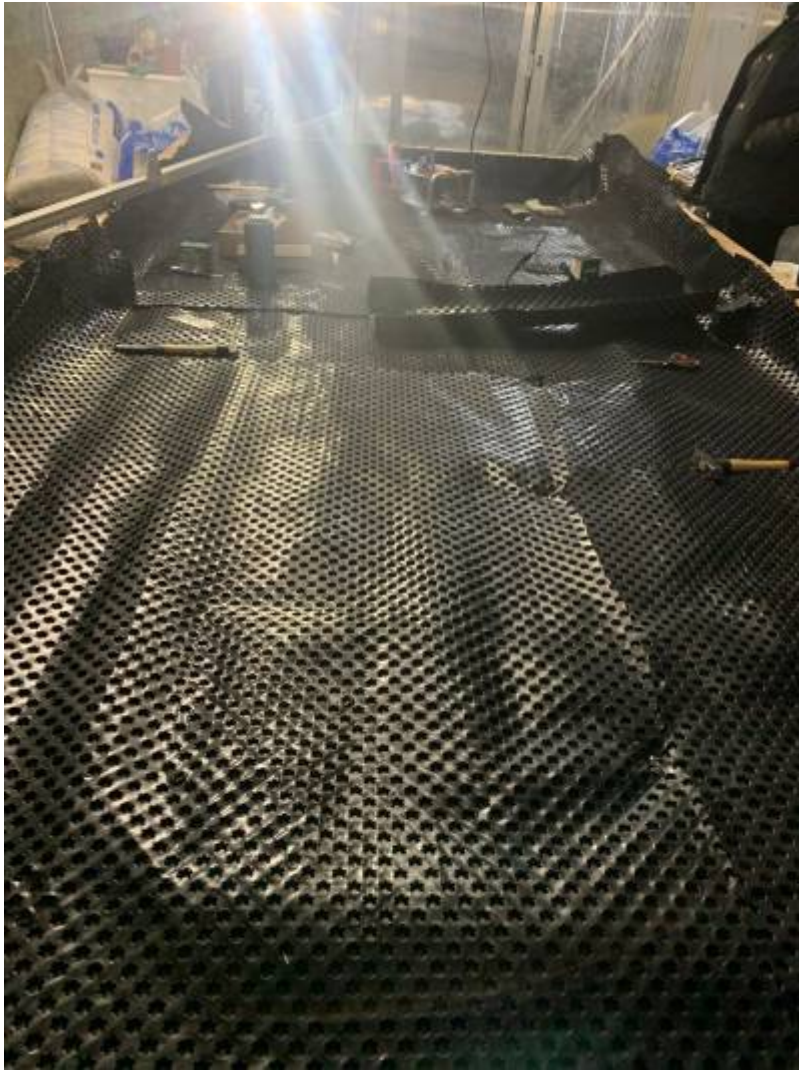
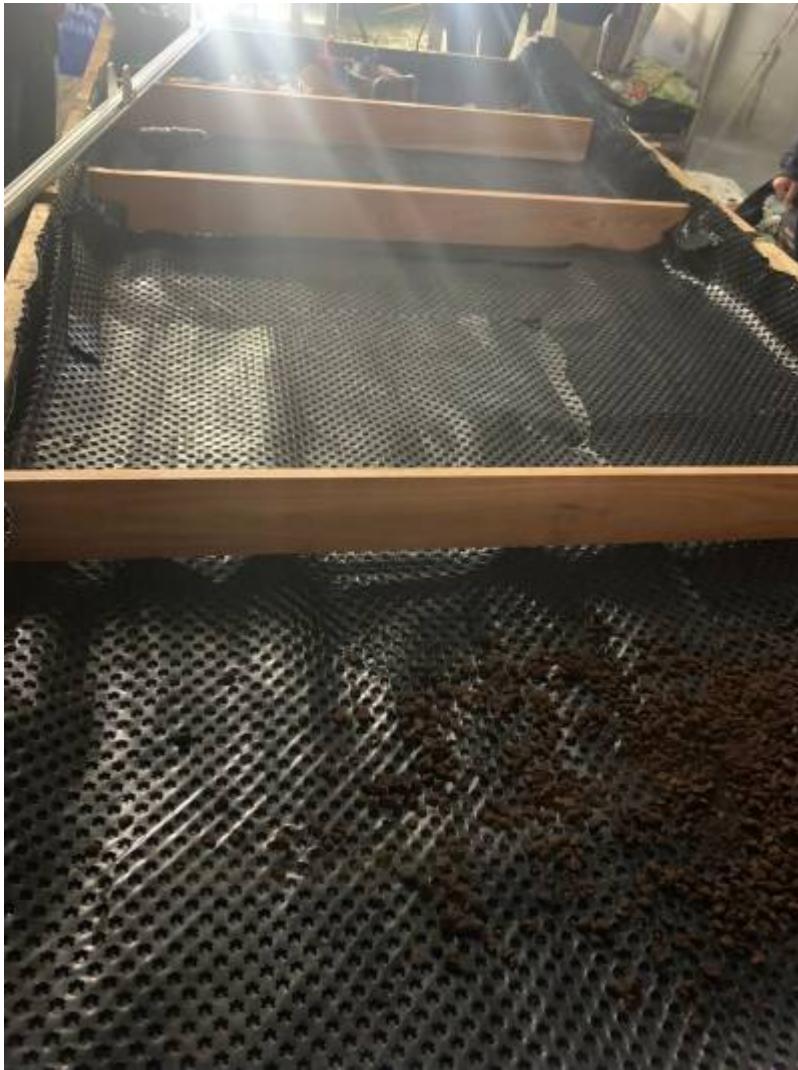
Fig - 5 Installation of drainage net and dividers

The plant bed structure consisted of a wooden frame that was 4m long, 2m wide, and 23cm deep. The plant bed was slightly inclined on the left side to facilitate the flow of excess water to the side and out of the plant bed, and 3 wooden dividers were added to create 4 separate planting sections.

The 4 layers in the bed were a drainage net, pumice stones, a combination of perlite and black soil, and compost. The purpose of the plastic drainage net was to help in aeration while preventing water from stagnating at the bottom, which would not only damage the wooden floor but also cause water-related diseases to the roots.

Figure 5 showed the installation of wooden dividers and the plastic drainage net.

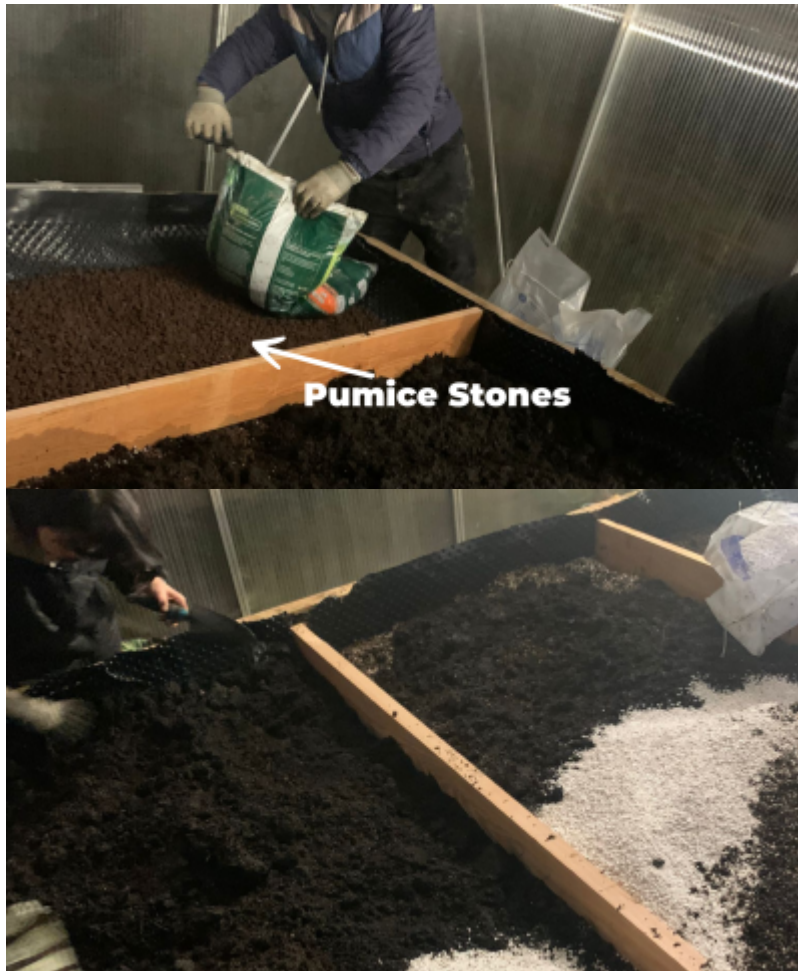
Fig - 6 Pumice stones later (Left) and black soil and perlite combination (right)

The Pumice stones were added to provide aeration to the soil, which helped enhance the soil structure, preventing soil compaction that created space for better drainage. In addition, because of its ability to trap and release substances, in this case, nutrients, it improved the nutrient exchange capacity of the soil, Abbu et al. (2023).<sup>2</sup>

Figure 6 shows a picture of the pumice stone layer (Left)

A mix of perlite and black soil was chosen as the second layer from the top because the porous properties of perlite allowed for aeration while the black soil helped with drainage and water retention. The perlite prevented soil compaction, while the black soil enhanced the overall soil structure while containing organic matter, which contributed to nutrient availability.

Figure 6 shows a picture of the Black soil and perlite combination (right)

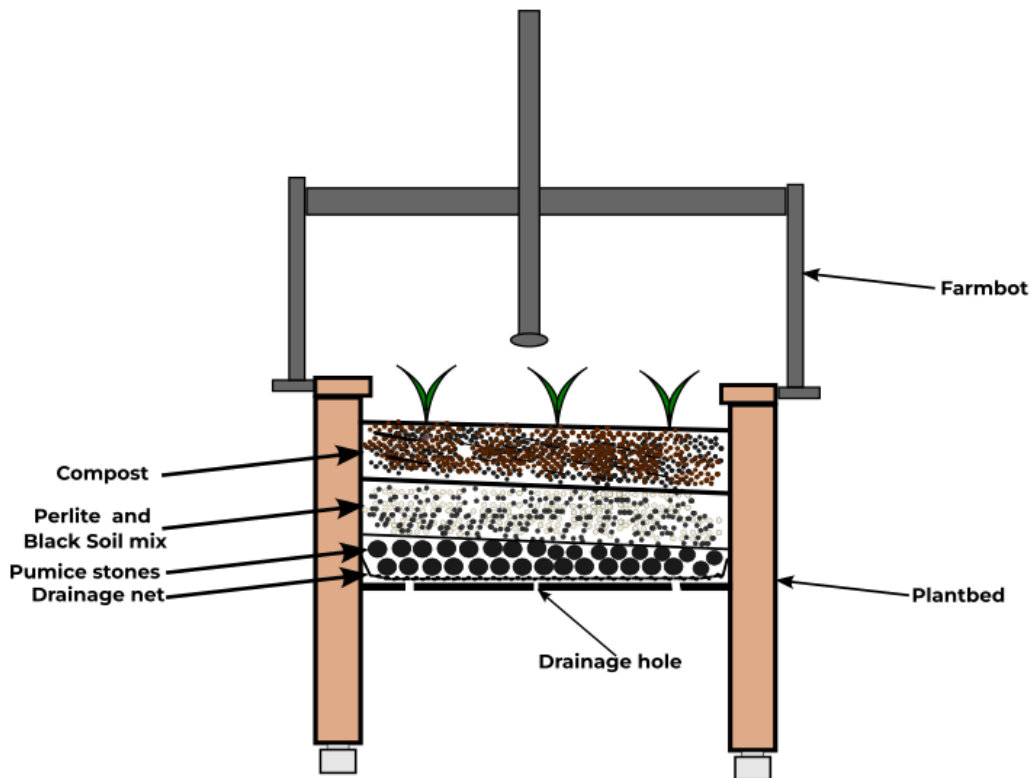
Fig - 7 The different layers on the frontal plane.

Figure 7 showed the different layers of the plant bed. The top layer consisted of compost, chosen to create the best environment for small-sized seeds, which couldn't be planted too deep where they would face difficulties emerging to the surface. Moreover, the compost helped to maintain a stable pH. However, to accommodate plants with specific pH needs higher or lower than 7, the compost layer was half the size of the perlite-black soil mix layer. This was to allow the perlite to compensate for pH levels higher or lower than required where necessary, Compost Science and Technology (2007)

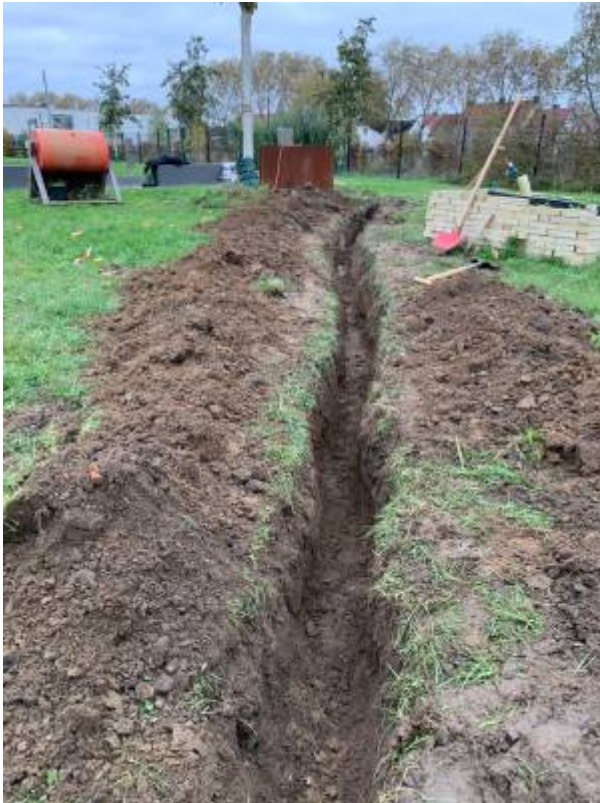
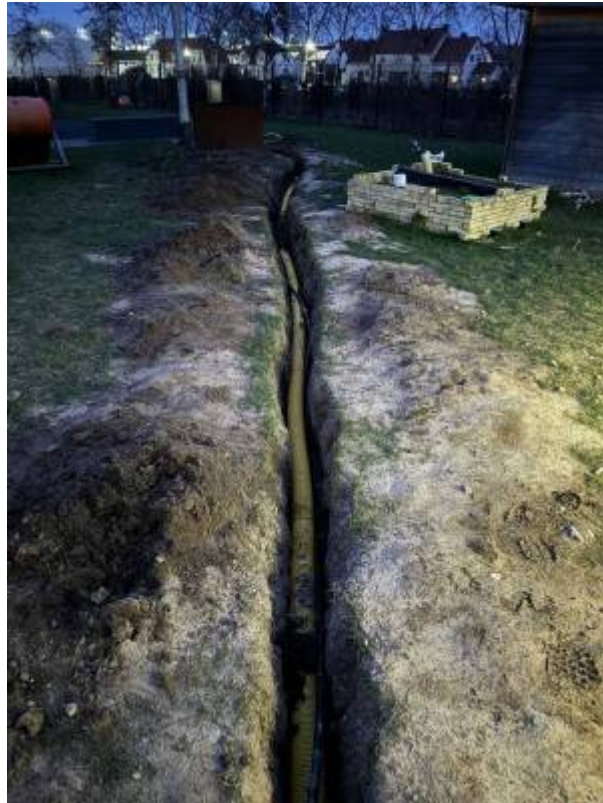
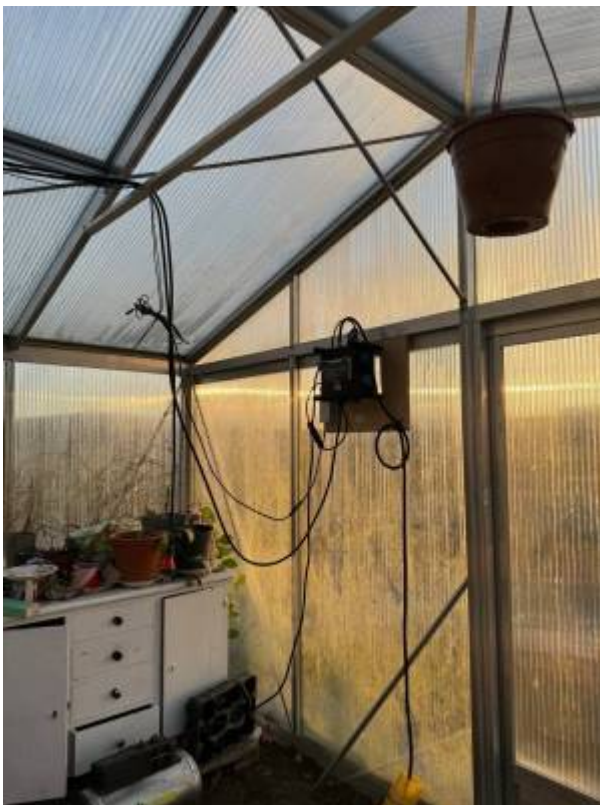
Firstly, we needed to provide the greenhouse with enough electricity to not just power the Farmbot but also other components like the electric heaters, the plant LEDs and the U6 mesh repeater. This required a 22m long and 50cm deep trench to be dug through the mapped out area as seen in Figure 8. It was the most excruciating part of the project. Once the trench was dug, we had to pass the electrical line through a protective cable duct. This part required us to be extra creative and a video of how we accomplished it was recorded in [Vid\\_1](#) and [Vid\\_2](#). The cable was then laid into the trench.

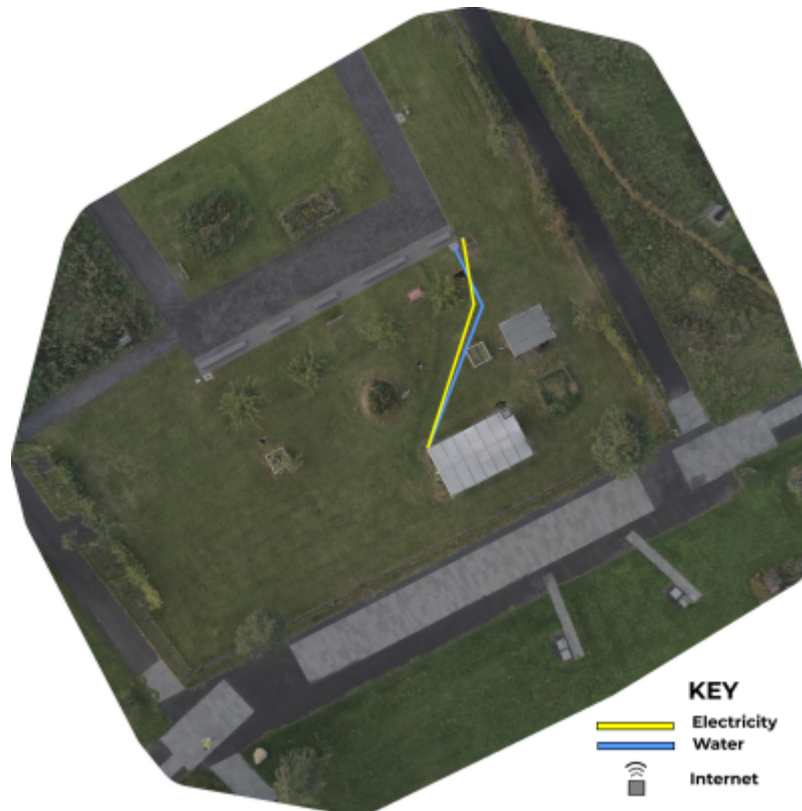
Fig - 8 A sketch of an aerial view of the underground piping line

The next was to establish a water connect with an inlet at the water source which was just beside the one for electricity, and an outlet in the greenhouse. Both were linked with a simple pipe equipped with a pressure equalizer. The mapping of both water and electric lines can be seen in Figure 8.

One of the hardest but noteworthy achievements of the project was the establishment of direct access to water, electricity, and the internet—essential resources. The in-pipe system and panels inside the greenhouse not only ensured a stable supply of resources but also contributed to making the whole system sustainable and self-reliant, a major goal of the project.

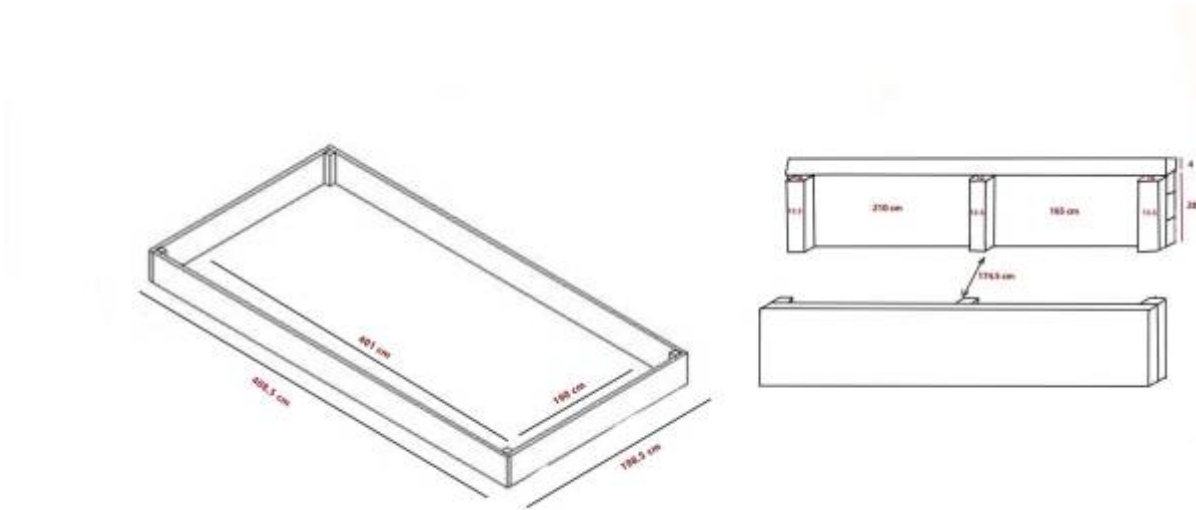
Fig - 9 A sketch of the plant bed measurement

Based on the measurement of the raised bed in **Fig.9**, the volume of the soil that the table could hold was  $4.01\text{m} * 1.9\text{m} * 0.2\text{m} = 1.5238\text{m}^3$  which was 1523.8 Liters.

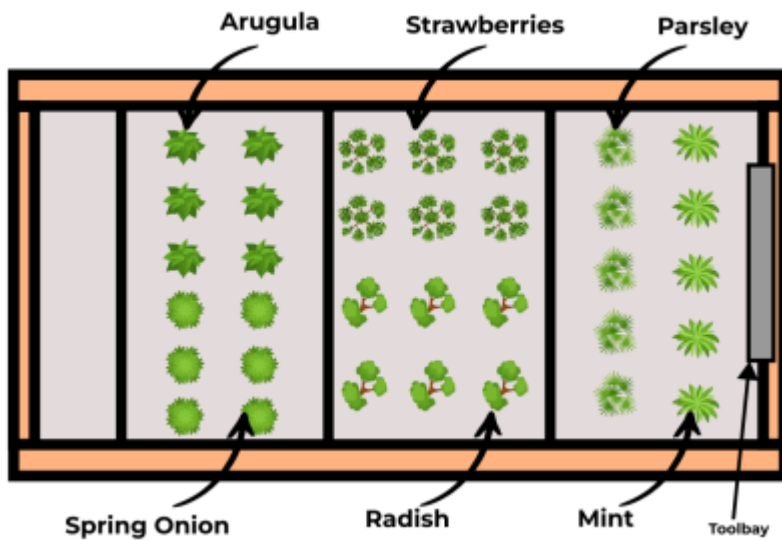
Fig - 10 illustration of the plant species as seen from above.

**Strawberries and Radish:** Strawberries are picky plants when it comes to their soil preferences. They like acidic soil that drains very well and they need lots of nutrients as they grow and develop. Radish however is less picky but known to thrive better on similar soil mixture as strawberries. Therefore, we have prepared a soil mixture that had every component in equal measurement and planted both species in the same section.<sup>5</sup>

**Parsley and Mint:** Parsley and mint both are very easygoing plants and do well in a container/pot environment. Both prefer moderate fertilisation and similar watering needs. Therefore we prepared a soil mixture that consists of 60% black soil, %30 compost, %10 perlite for drainage and acidity.

**Arugula and Spring Onion:** Arugula and Spring Onions prefer nutrient-rich, well-drained soil but are very tolerant plants. They tend to germinate slightly colder soil than any other plants in our lists so we decided to plant them together. We used %40 black soil, %30 compost, %15 pumice and %15 perlite to maintain good drainage, aeration and acidity of the soil.<sup>6</sup>

The position of the plants was illustrated in Figure 10

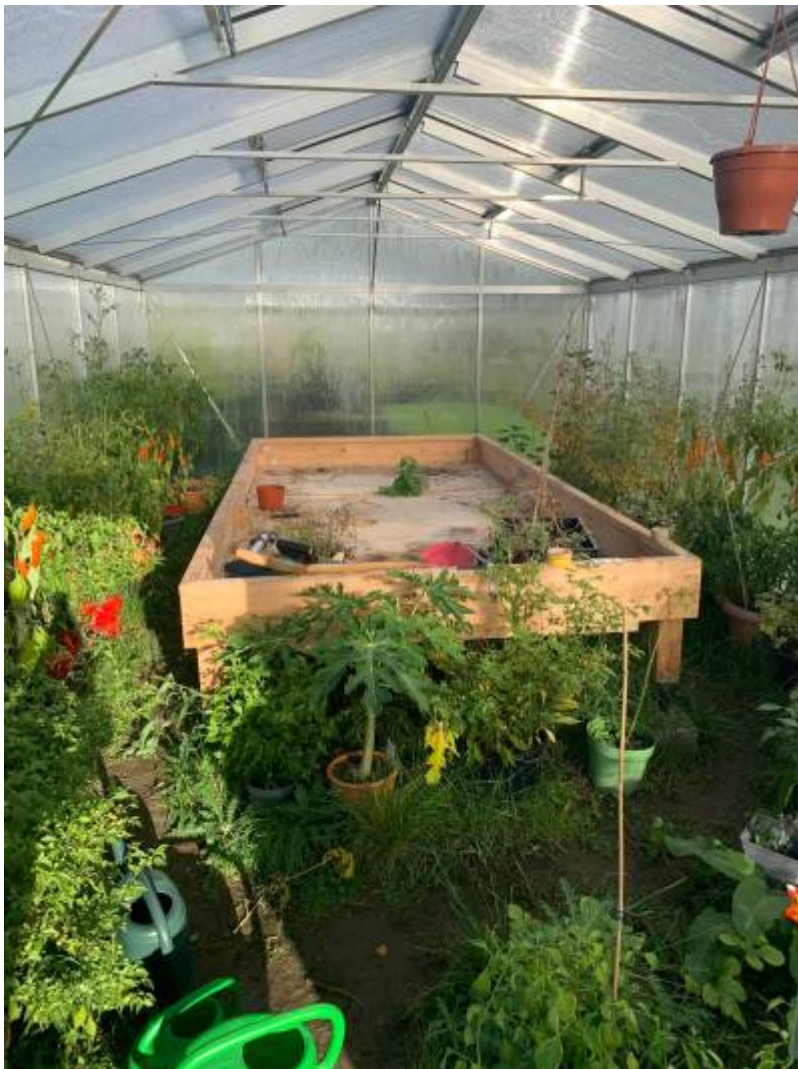
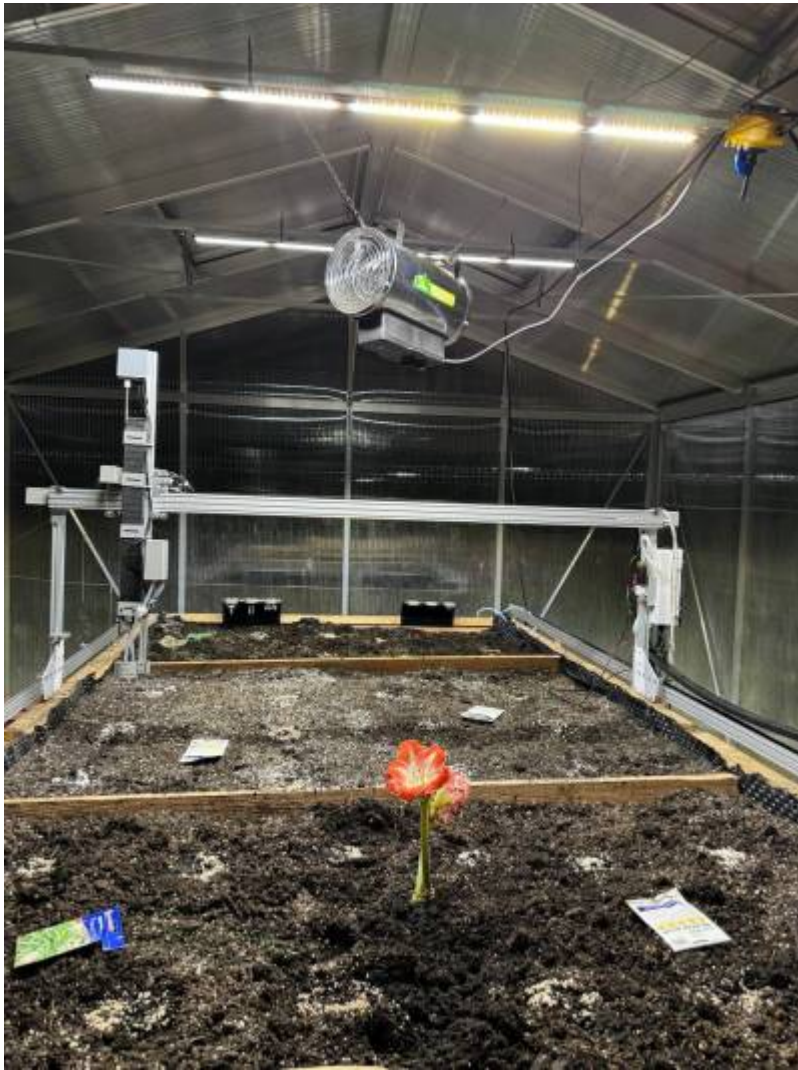
Fig - 11 the greenhouse before and after the Farmbot

The before-and-after images in figure **11** illustrated the transformative effect the project had on the greenhouse. From the construction of the FarmBot to the ease of access to water and electricity, the greenhouse was positively impacted by this project.
