# ColLab Garden

## TITLE: Co-Creating The Future Of The GFL Greenhouse

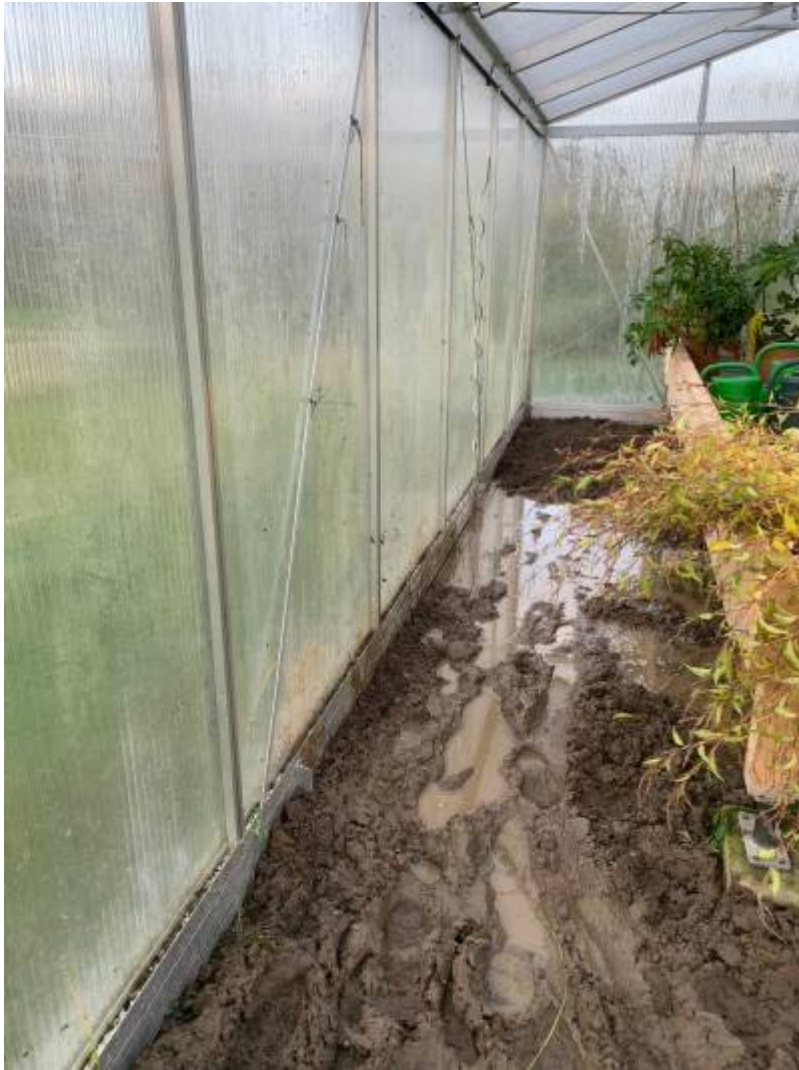
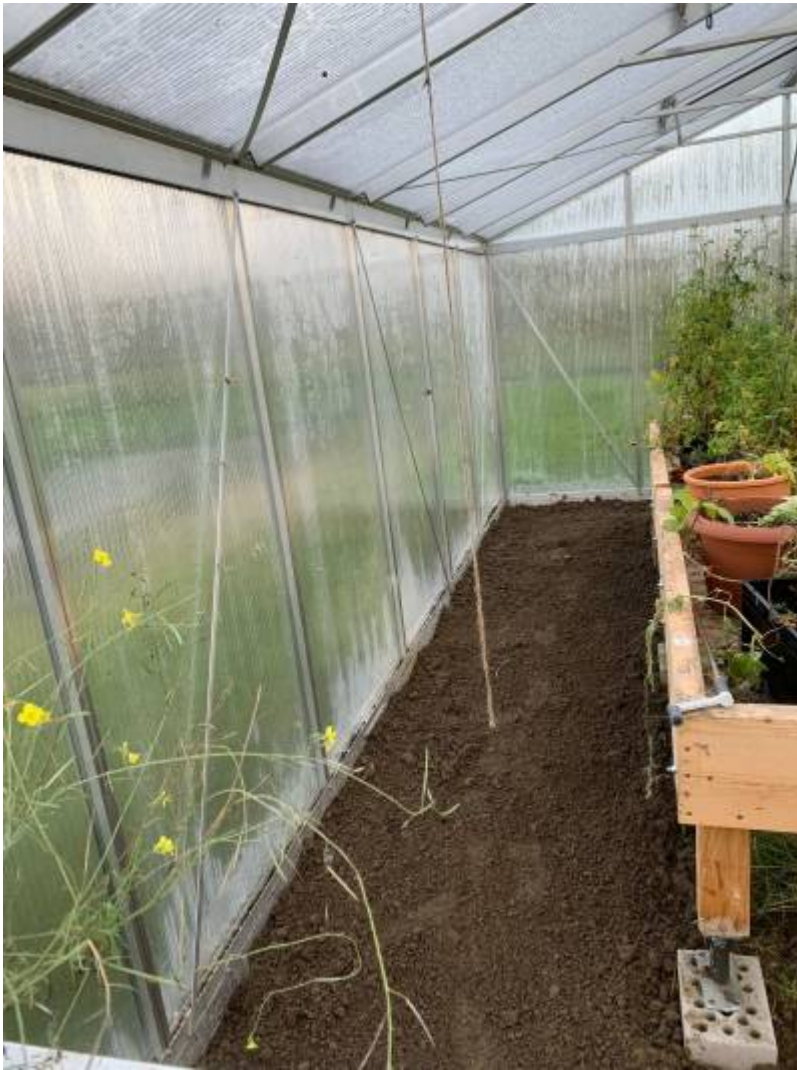
Fig - 3 Progress of Greenhouse before and after cleaning (Side view)

Figures **2** and **3** show the progress of cleaning both from the front and the side view

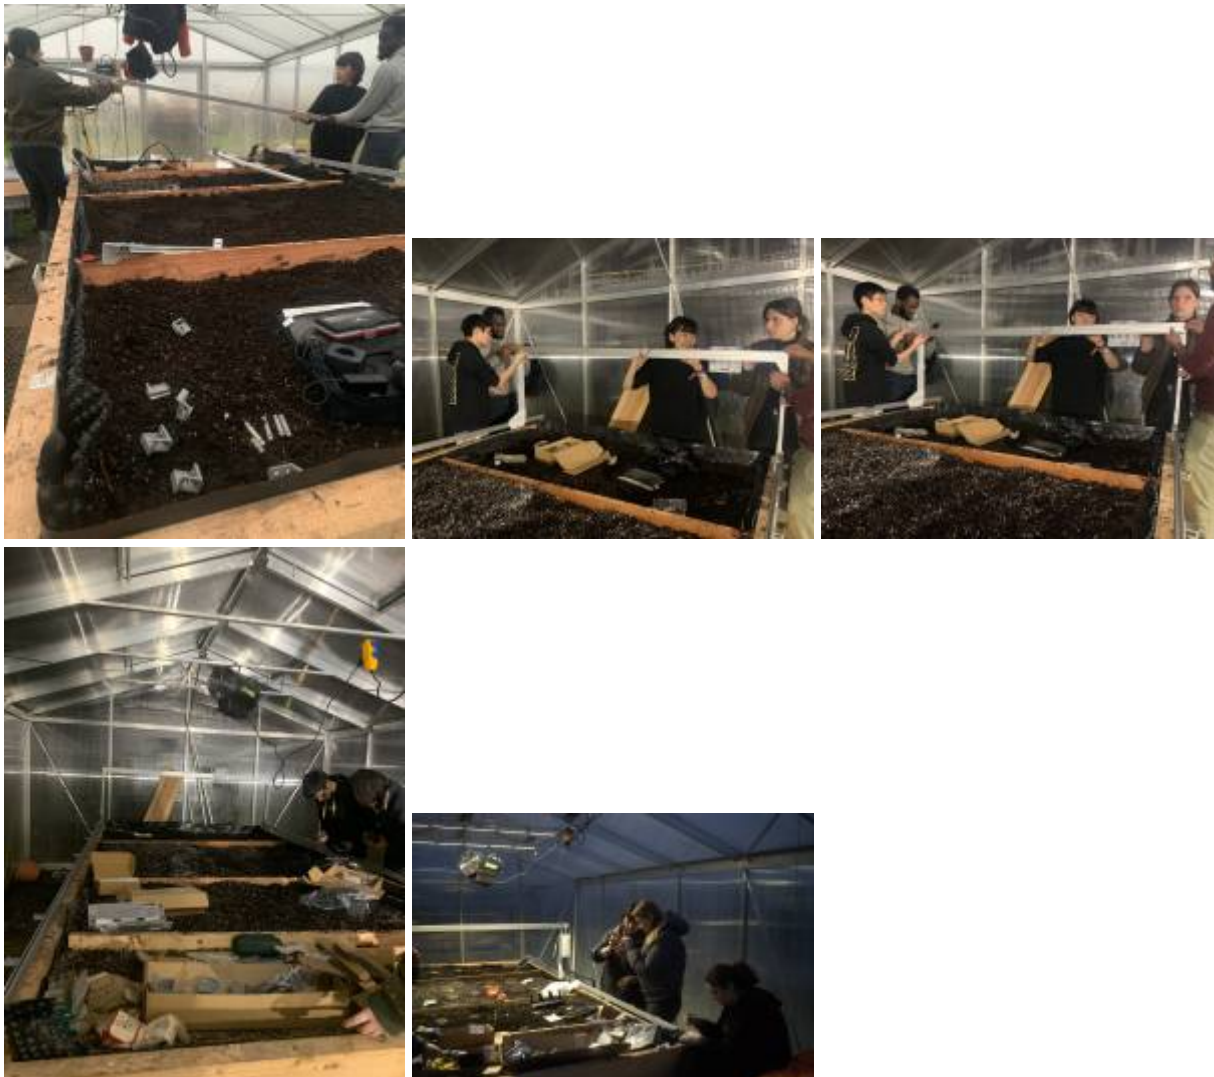
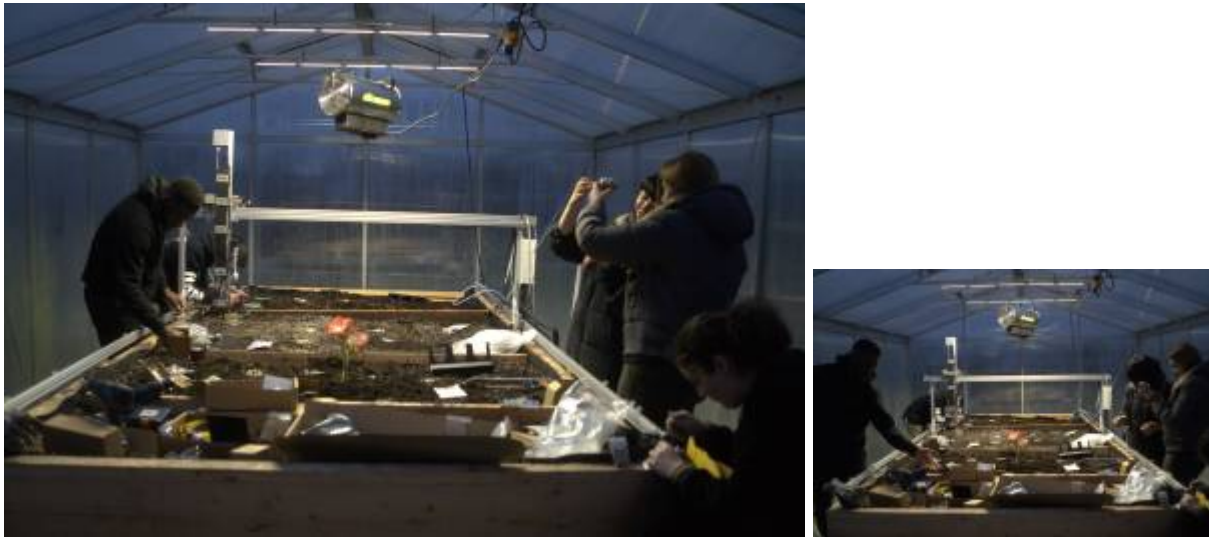
Fig - 4 Building the FarmBot piece by piece by the team members

FarmBot Genesis XL version 1.6. It was chosen because of its multifunctional capabilities, ranging from planting a seed to nursing it to maturity. Additionally, it excelled in weeding and soil sensitivity measurement. Besides being autonomous in numerous functions, it was also built upon open-source data that could be modified based on preferences and needs. Its components all contributed to an advanced approach to farming, especially on an individual level. The progress in building the Farmbot was documented in the pictures shown below in Figure 4. Most importantly, the FarmBot could be assembled and used not just by technology experts but also by individuals with little to no experience in the field. Its main parts were the gantry with a Z-axis hand and the tracks for movement with cable carriers. It also had several tools for seeding, weeding, and watering placed in a toolbar at the edge of the plant bed. Finally, there was a main electrical box attached to it that oversaw all operations. A simple diagram showing the Farmbot view from all 3 planes could be seen in Figure 4.1.

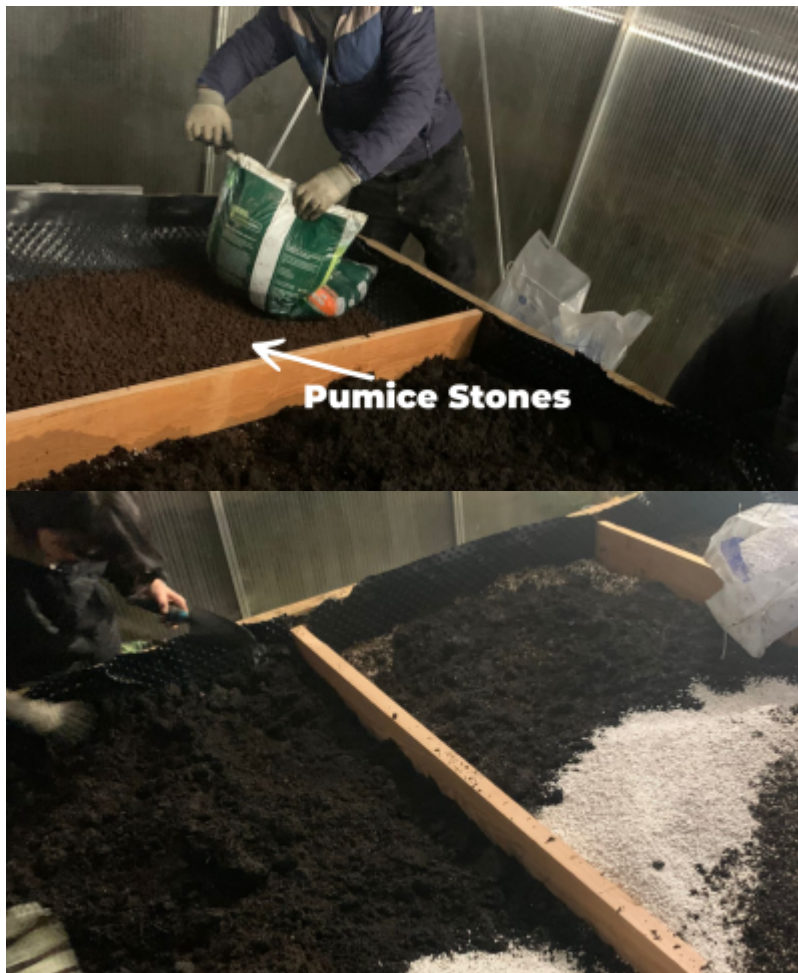
Fig - 6 Pumice stones later (Left) and black soil and perlite combination (right)

The Pumice stones were added to provide aeration to the soil, which helped enhance the soil structure, preventing soil compaction that created space for better drainage. In addition, because of its ability to trap and release substances, in this case, nutrients, it improved the nutrient exchange capacity of the soil, Abbu et al. (2023).<sup>2</sup>

Figure 6 shows a picture of the pumice stone layer (Left)

A mix of perlite and black soil was chosen as the second layer from the top because the porous properties of perlite allowed for aeration while the black soil helped with drainage and water retention. The perlite prevented soil compaction, while the black soil enhanced the overall soil structure while containing organic matter, which contributed to nutrient availability.

Figure 6 shows a picture of the Black soil and perlite combination (right)

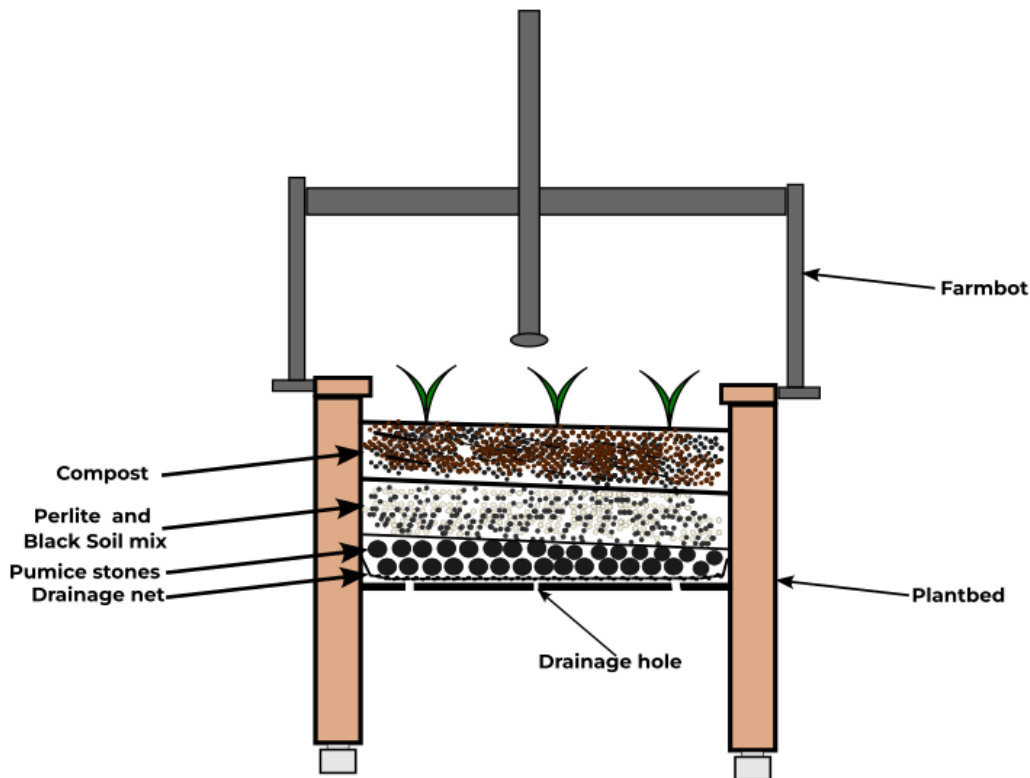
Fig - 7 The different layers on the frontal plane.

Figure 7 showed the different layers of the plant bed. The top layer consisted of compost, chosen to create the best environment for small-sized seeds, which couldn't be planted too deep where they would face difficulties emerging to the surface. Moreover, the compost helped to maintain a stable pH. However, to accommodate plants with specific pH needs higher or lower than 7, the compost layer was half the size of the perlite-black soil mix layer. This was to allow the perlite to compensate for pH levels higher or lower than required where necessary, Compost Science and Technology (2007)

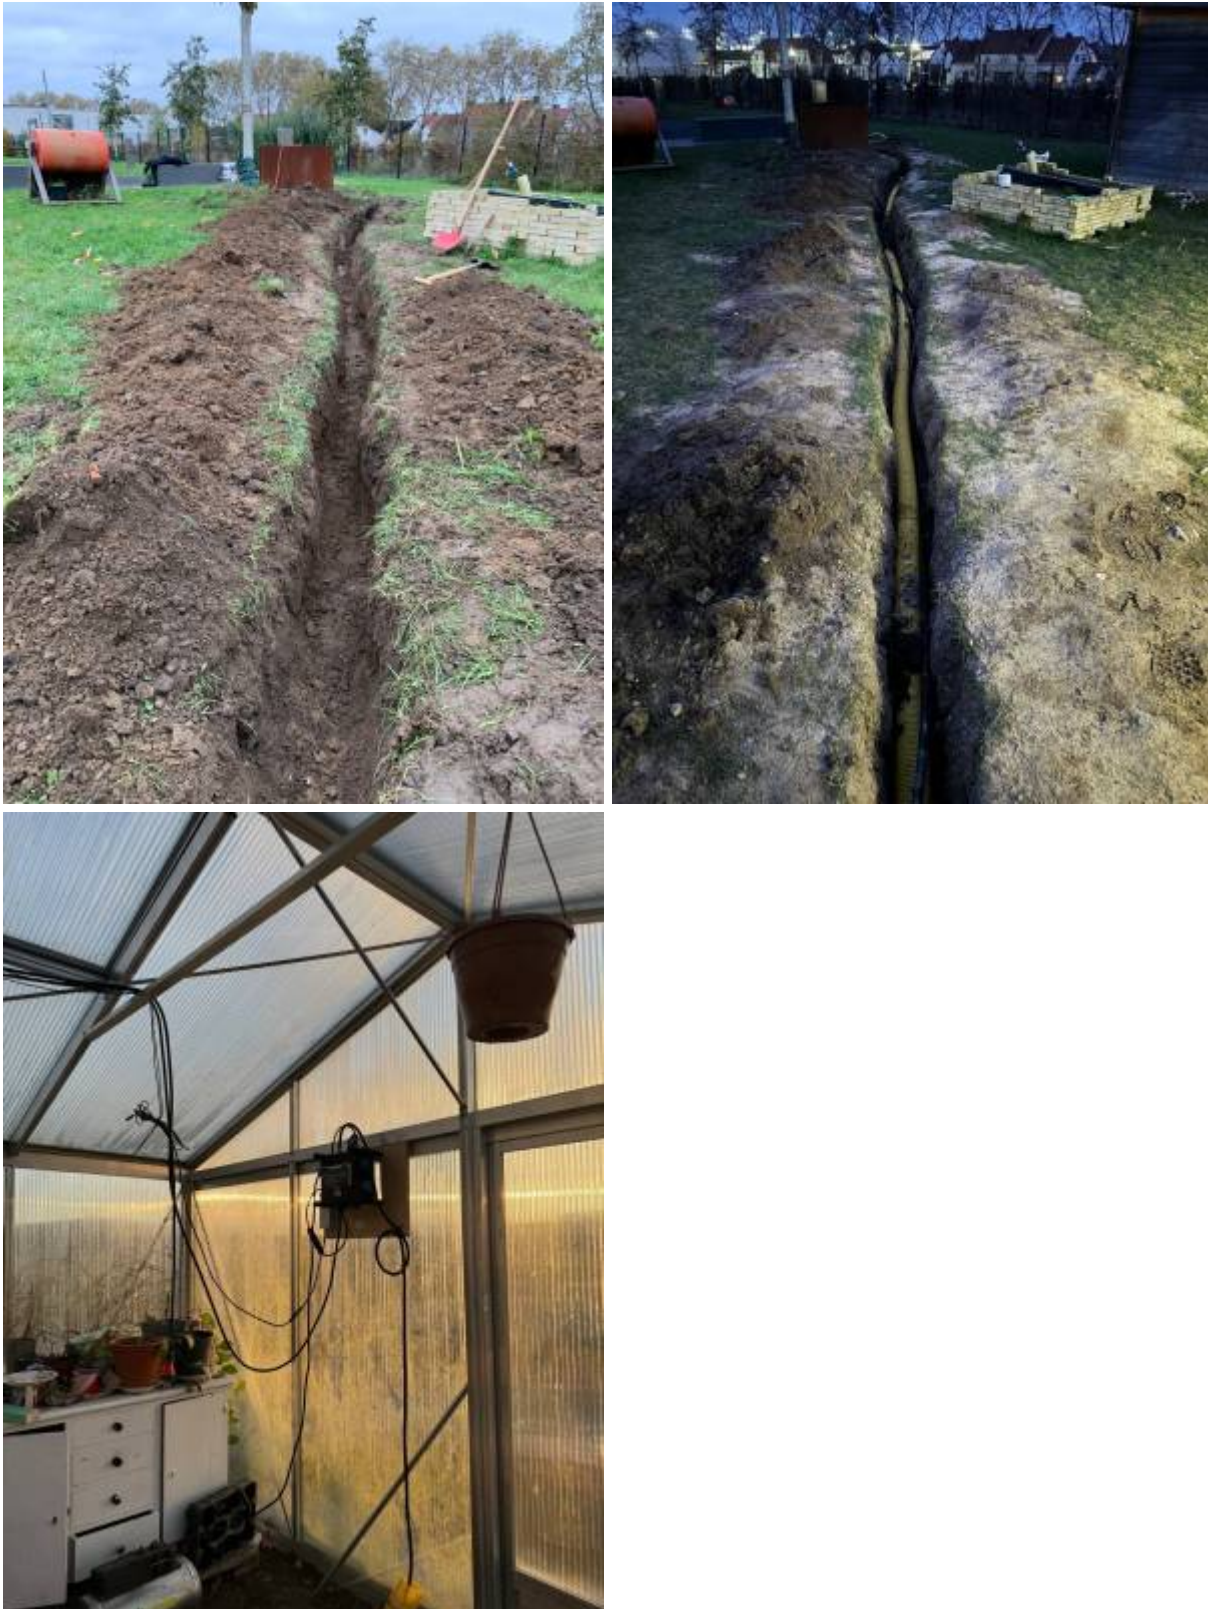
Fig - 8 Pictures of the Trench before the pipe (Left), after the pipe (middle) and the electrical hub (right)

Firstly, we needed to provide the greenhouse with enough electricity to not just power the Farmbot but also other components like the electric heaters, the plant LEDs and the U6 mesh repeater. This required a 22m long and 50cm deep trench to be dug through the mapped out area as seen in Figure 8. It was the most excruciating part of the project. Once the trench was dug, we had to pass the electrical line through a protective cable duct. This part required us to be extra creative and a video of how we accomplished it was recorded in [Vid\\_1](#) and [Vid\\_2](#). The cable was then laid into the trench. And connect on the inside to an electrical hub This can be seen in Figure 8.

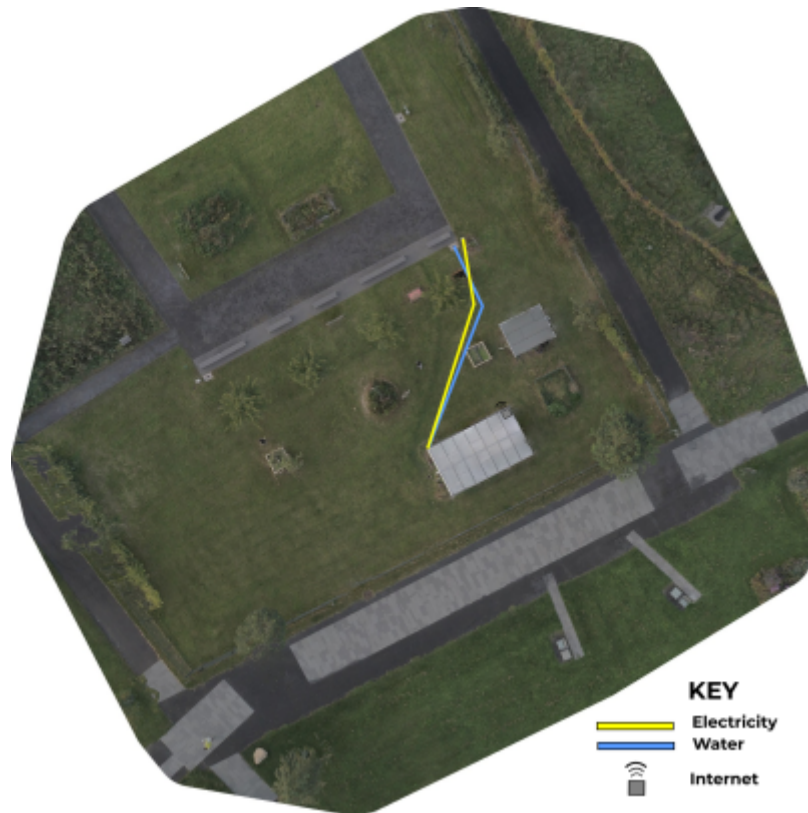
Fig - 8.1 A sketch of an aerial view of the underground piping line

The next was to establish a water connect with an inlet at the water source which was just beside the one for electricity, and an outlet in the greenhouse. Both were linked with a simple pipe equipped with a pressure equalizer. The mapping of both water and electric lines can be seen in Figure **8.1**.

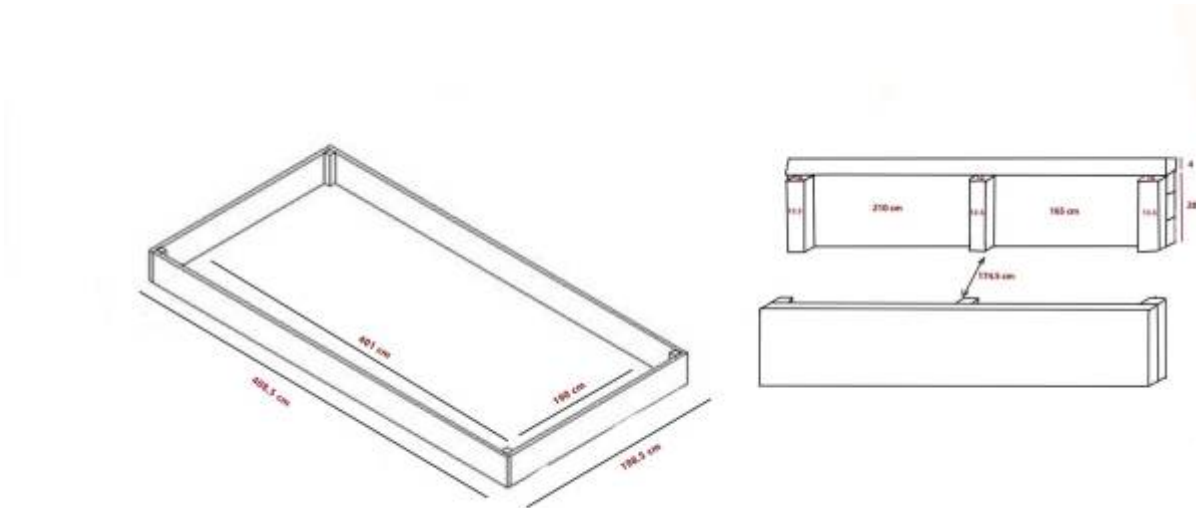
Fig - 9 A sketch of the plant bed measurement

Based on the measurement of the raised bed in **Fig.9**, the volume of the soil that the table could hold was  $4.01\text{m} * 1.9\text{m} * 0.2\text{m} = 1.5238\text{m}^3$  which was 1523.8 Liters.

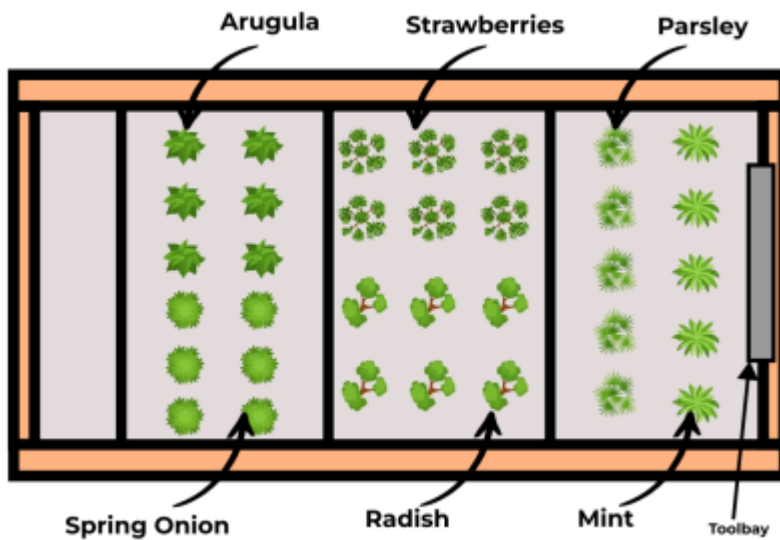
Fig - 10 illustration of the plant species as seen from above.

**Strawberries and Radish:** Strawberries are picky plants when it comes to their soil preferences. They like acidic soil that drains very well and they need lots of nutrients as they grow and develop. Radish however is less picky but known to thrive better on similar soil mixture as strawberries. Therefore, we have prepared a soil mixture that had every component in equal measurement and planted both species in the same section.<sup>5</sup>

**Parsley and Mint:** Parsley and mint both are very easygoing plants and do well in a container/pot environment. Both prefer moderate fertilisation and similar watering needs. Therefore we prepared a soil mixture that consists of 60% black soil, %30 compost, %10 perlite for drainage and acidity.

**Arugula and Spring Onion:** Arugula and Spring Onions prefer nutrient-rich, well-drained soil but are very tolerant plants. They tend to germinate slightly colder soil than any other plants in our lists so we decided to plant them together. We used %40 black soil, %30 compost, %15 pumice and %15 perlite to maintain good drainage, aeration and acidity of the soil.<sup>6</sup>

The position of the plants was illustrated in Figure 10
