# Open-Source Wifi Camera

The idea behind this project is to provide a base platform that can be used in different visual monitoring activities. First, it was needed in a birdhouse project where a birdhouse should be monitored over an extended period.

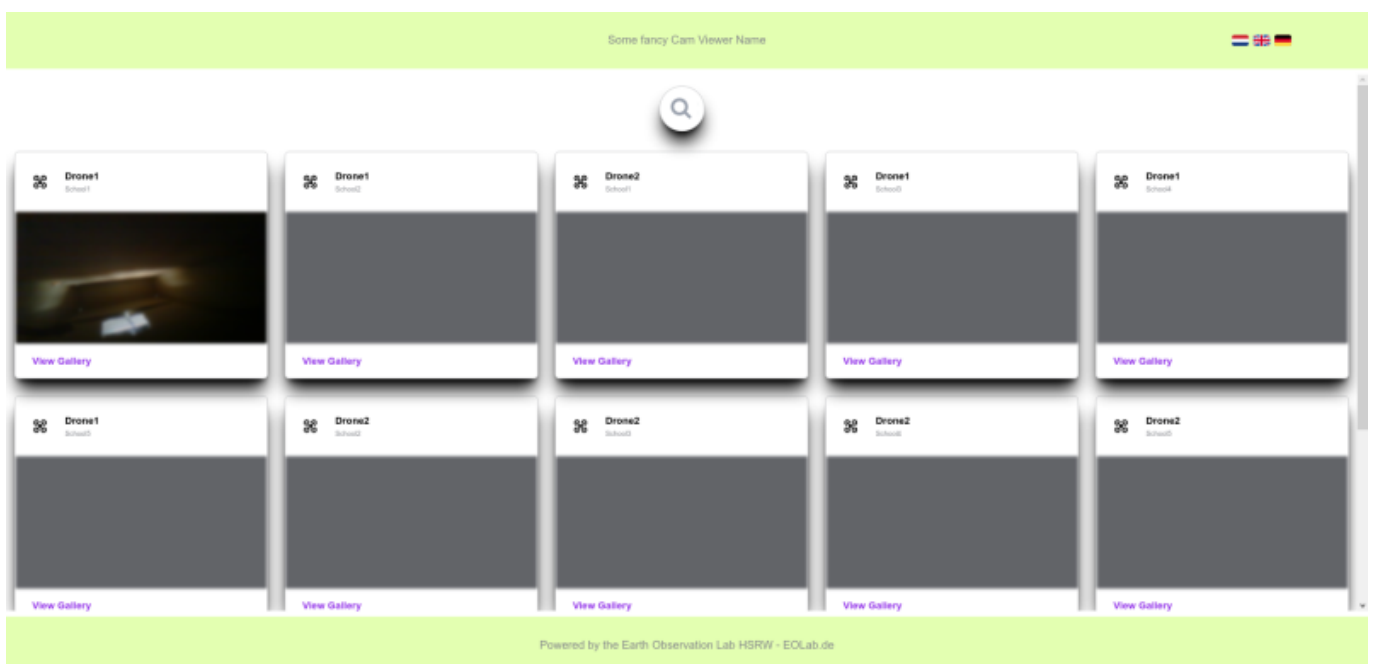
## Online Viewing Software

After starting the development of the second prototype we also started working on an open-source platform to view all the photos gathered by deployed versions of the hardware. In general, the software is built so other authenticated devices could upload photos as well.
