Open-Source Wifi Camera

The idea behind this project is to provide a base platform that can be used in different visual monitoring activities. First, it was needed in a birdhouse project where a birdhouse should be monitored over an extended period.

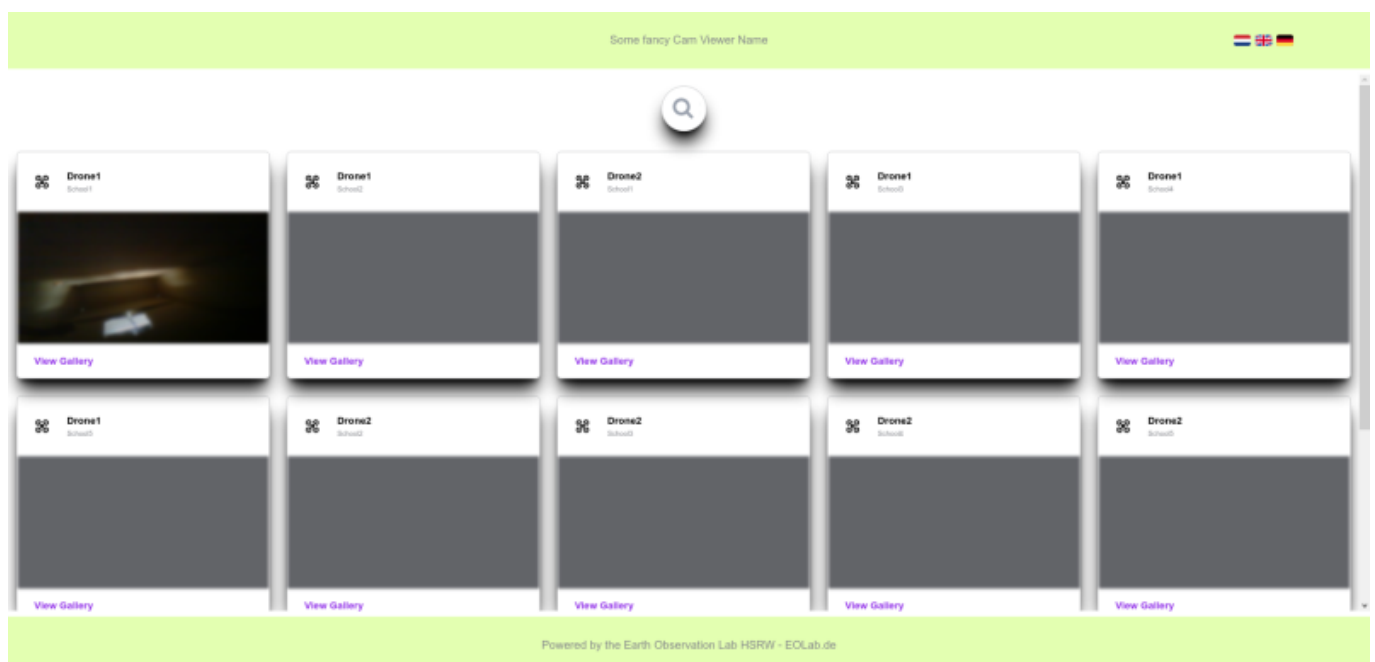
Online Viewing Software

After starting the development of the second prototype we also started working on an open-source platform to view all the photos gathered by deployed versions of the hardware. In general, the software is built so other authenticated devices could upload photos as well.
