Open-Source Wifi Camera

The idea behind this project is to provide a base platform that can be used in different visual monitoring activities. First, it was needed in a birdhouse project where a birdhouse should be monitored over an extended period.

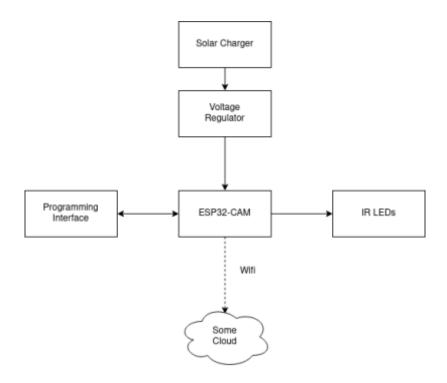
Block concept

- a rather small footprint (should fit in the top of a birdhouse)
- Wifi capable
- good enough image quality (photo) so you can actually identify something
- solar chargeable
- · night vision
- useable for other projects and also workshops
