Open-Source Wifi Camera

The idea behind this project is to provide a base platform that can be used in different visual monitoring activities. First, it was needed in a birdhouse project where a birdhouse should be monitored over an extended period.

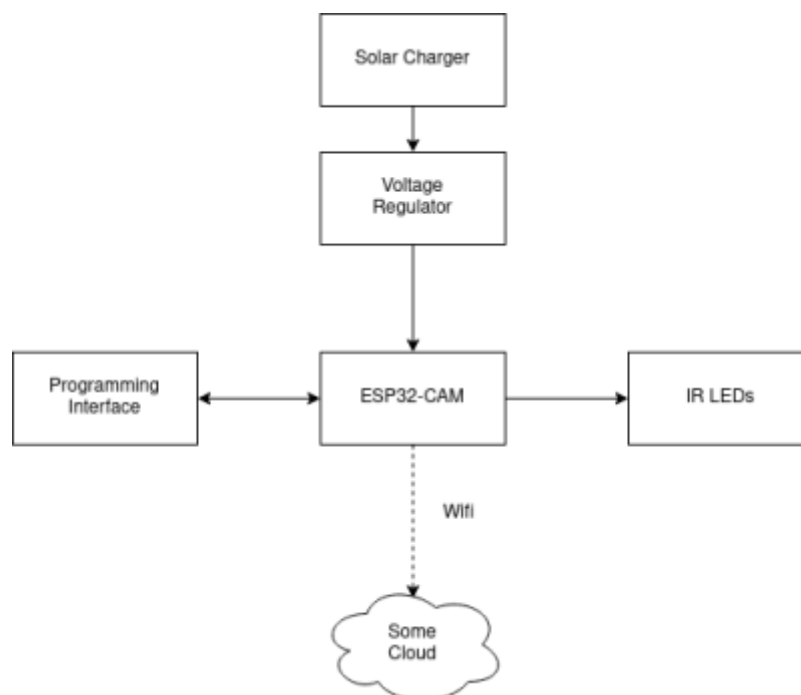
Block concept

- a rather small footprint (should fit in the top of a birdhouse)
- Wifi capable
- good enough image quality (photo) so you can actually identify something
- solar chargeable
- night vision
- useable for other projects and also workshops
