# Open-Source Wifi Camera

The idea behind this project is to provide a base platform that can be used in different visual monitoring activities. First, it was needed in a birdhouse project where a birdhouse should be monitored over an extended period.

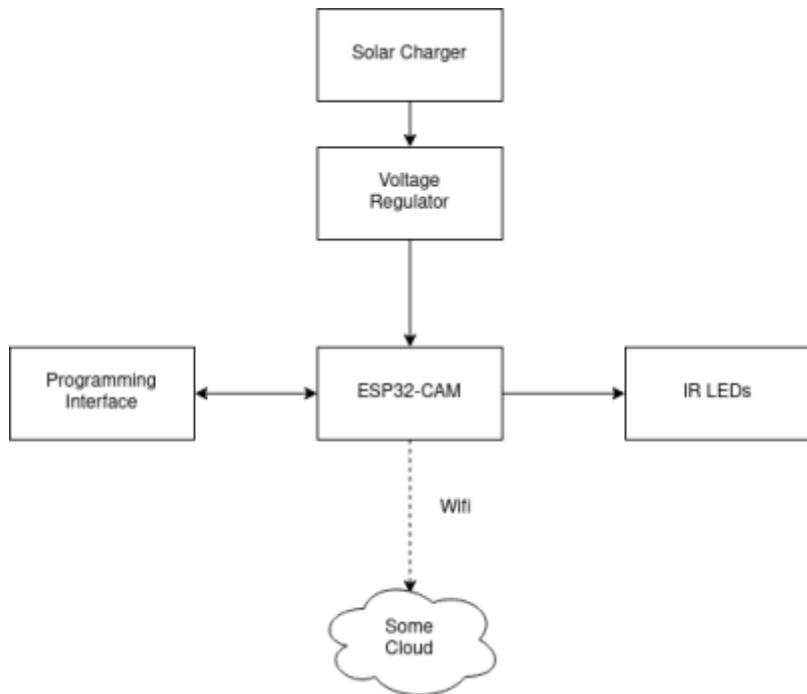
## Block concept

- a rather small footprint (should fit in the top of a birdhouse)
- Wifi capable
- good enough image quality (photo) so you can actually identify something
- solar chargeable
- night vision
- useable for other projects and also workshops

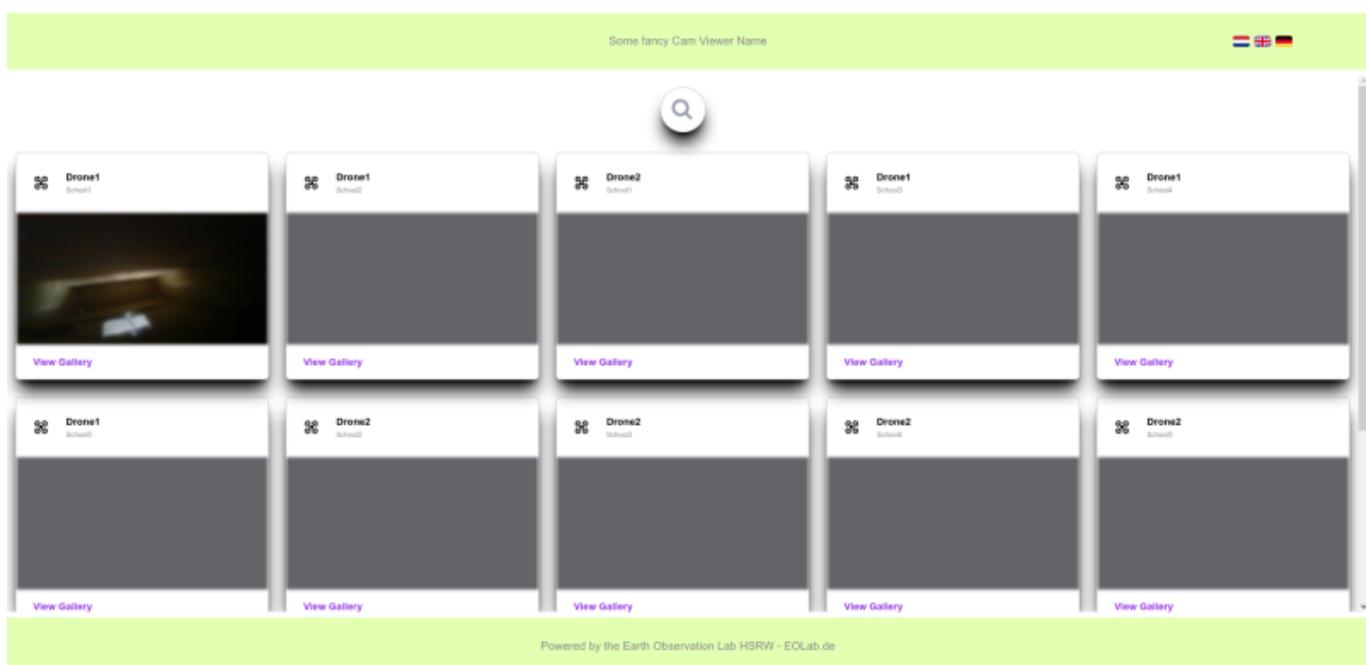
## Online Viewing Software

After starting the development of the second prototype we also started working on an open-source platform to view all the photos gathered by deployed versions of the hardware. In general, the software is built so other authenticated devices could upload photos as well.
