# Open-Source Wifi Camera

The idea behind this project is to provide a base platform that can be used in different visual monitoring activities. First, it was needed in a birdhouse project where a birdhouse should be monitored over an extended period.

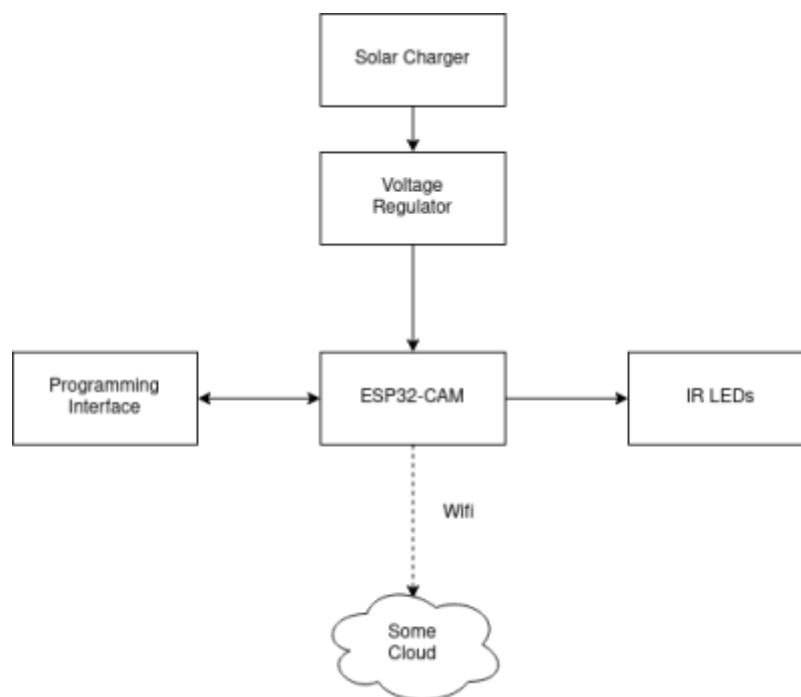
## Block concept

- a rather small footprint (should fit in the top of a birdhouse)
- Wifi capable
- good enough image quality (photo) so you can actually identify something
- solar chargeable
- night vision
- useable for other projects and also workshops

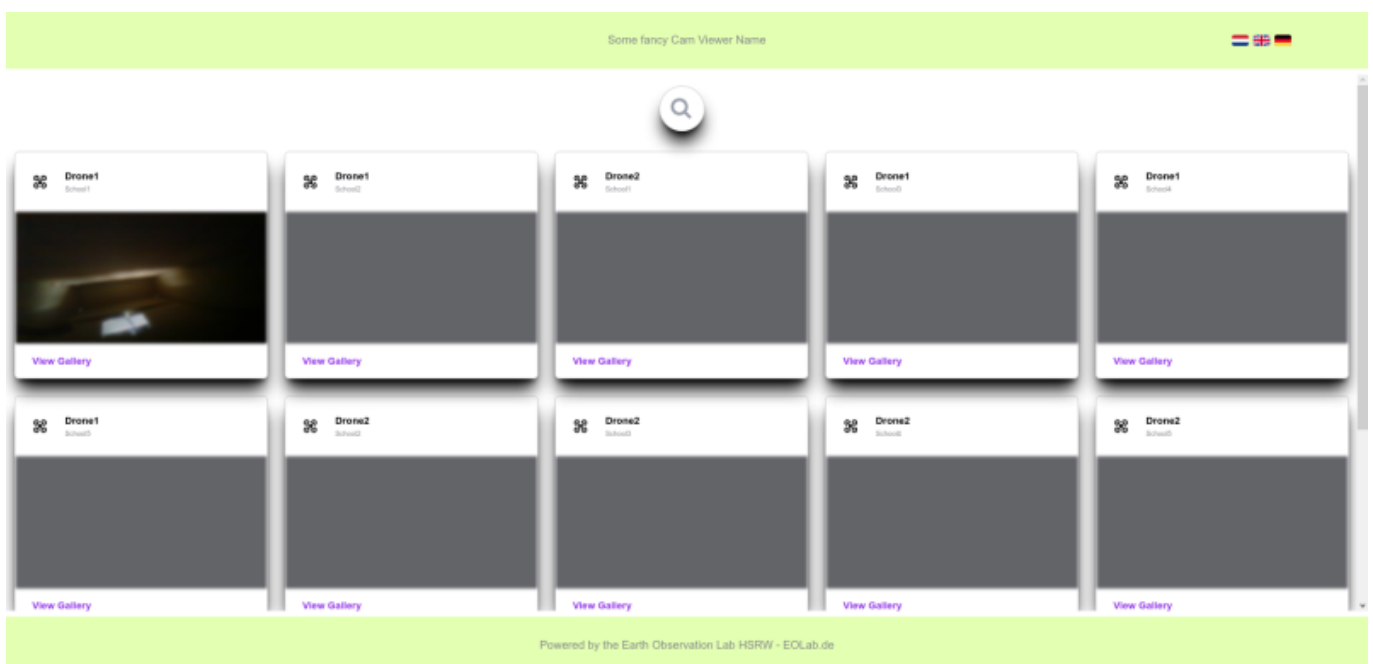
After starting the development of the second prototype we also started working on an open-source platform to view all the photos gathered by deployed versions of the hardware. In general, the software is built so other authenticated devices could upload photos as well.
